Reading, Writing, And Rooftop Coating: Recoating A Louisiana Elementary School

BY JENNIFER FRAKES
PHOTOS COURTESY OF ATD

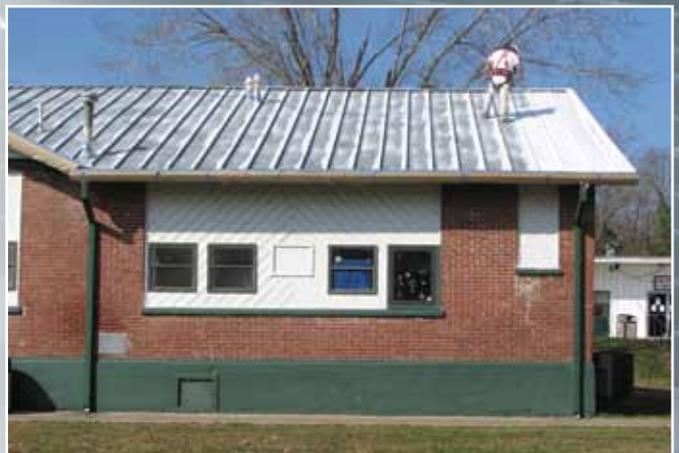
ABOVE ▲ In all, the ATD crew applied 60 gallons (227.13L) of PPG Coraflon ADS, a 2-component fluoropolymer coating, on top of the Coraflon primer. Using the same Graco equipment, the Coraflon ADS topcoat was spray-applied in two coats to achieve a total thickness of 5.5 to 6.0 mils (0.14mm to 0.15mm) DFT.

For this project, the two-man ATD crew applied 60 gallons (227.13L) of PPG Coraflon ADS, a two-component fluoropolymer coating, to the substrate. Prior to installing the topcoat, the crew applied two coats of PPG Coraflon 553/554 epoxy primer, which is recommended by PPG for use as the intermediate coat on steel and aluminum substrates. In total, 100 gallons (378.54L) of the primer was applied to the roof surface. Each coat of primer was applied at a thickness of 2.0 to 2.25 mils (0.051mm to 0.057mm) DFT, and the topcoat was applied in two

coats to achieve a total dry film thickness of 5.5 to 6.0 mils (0.14mm to 0.15mm) DFT.

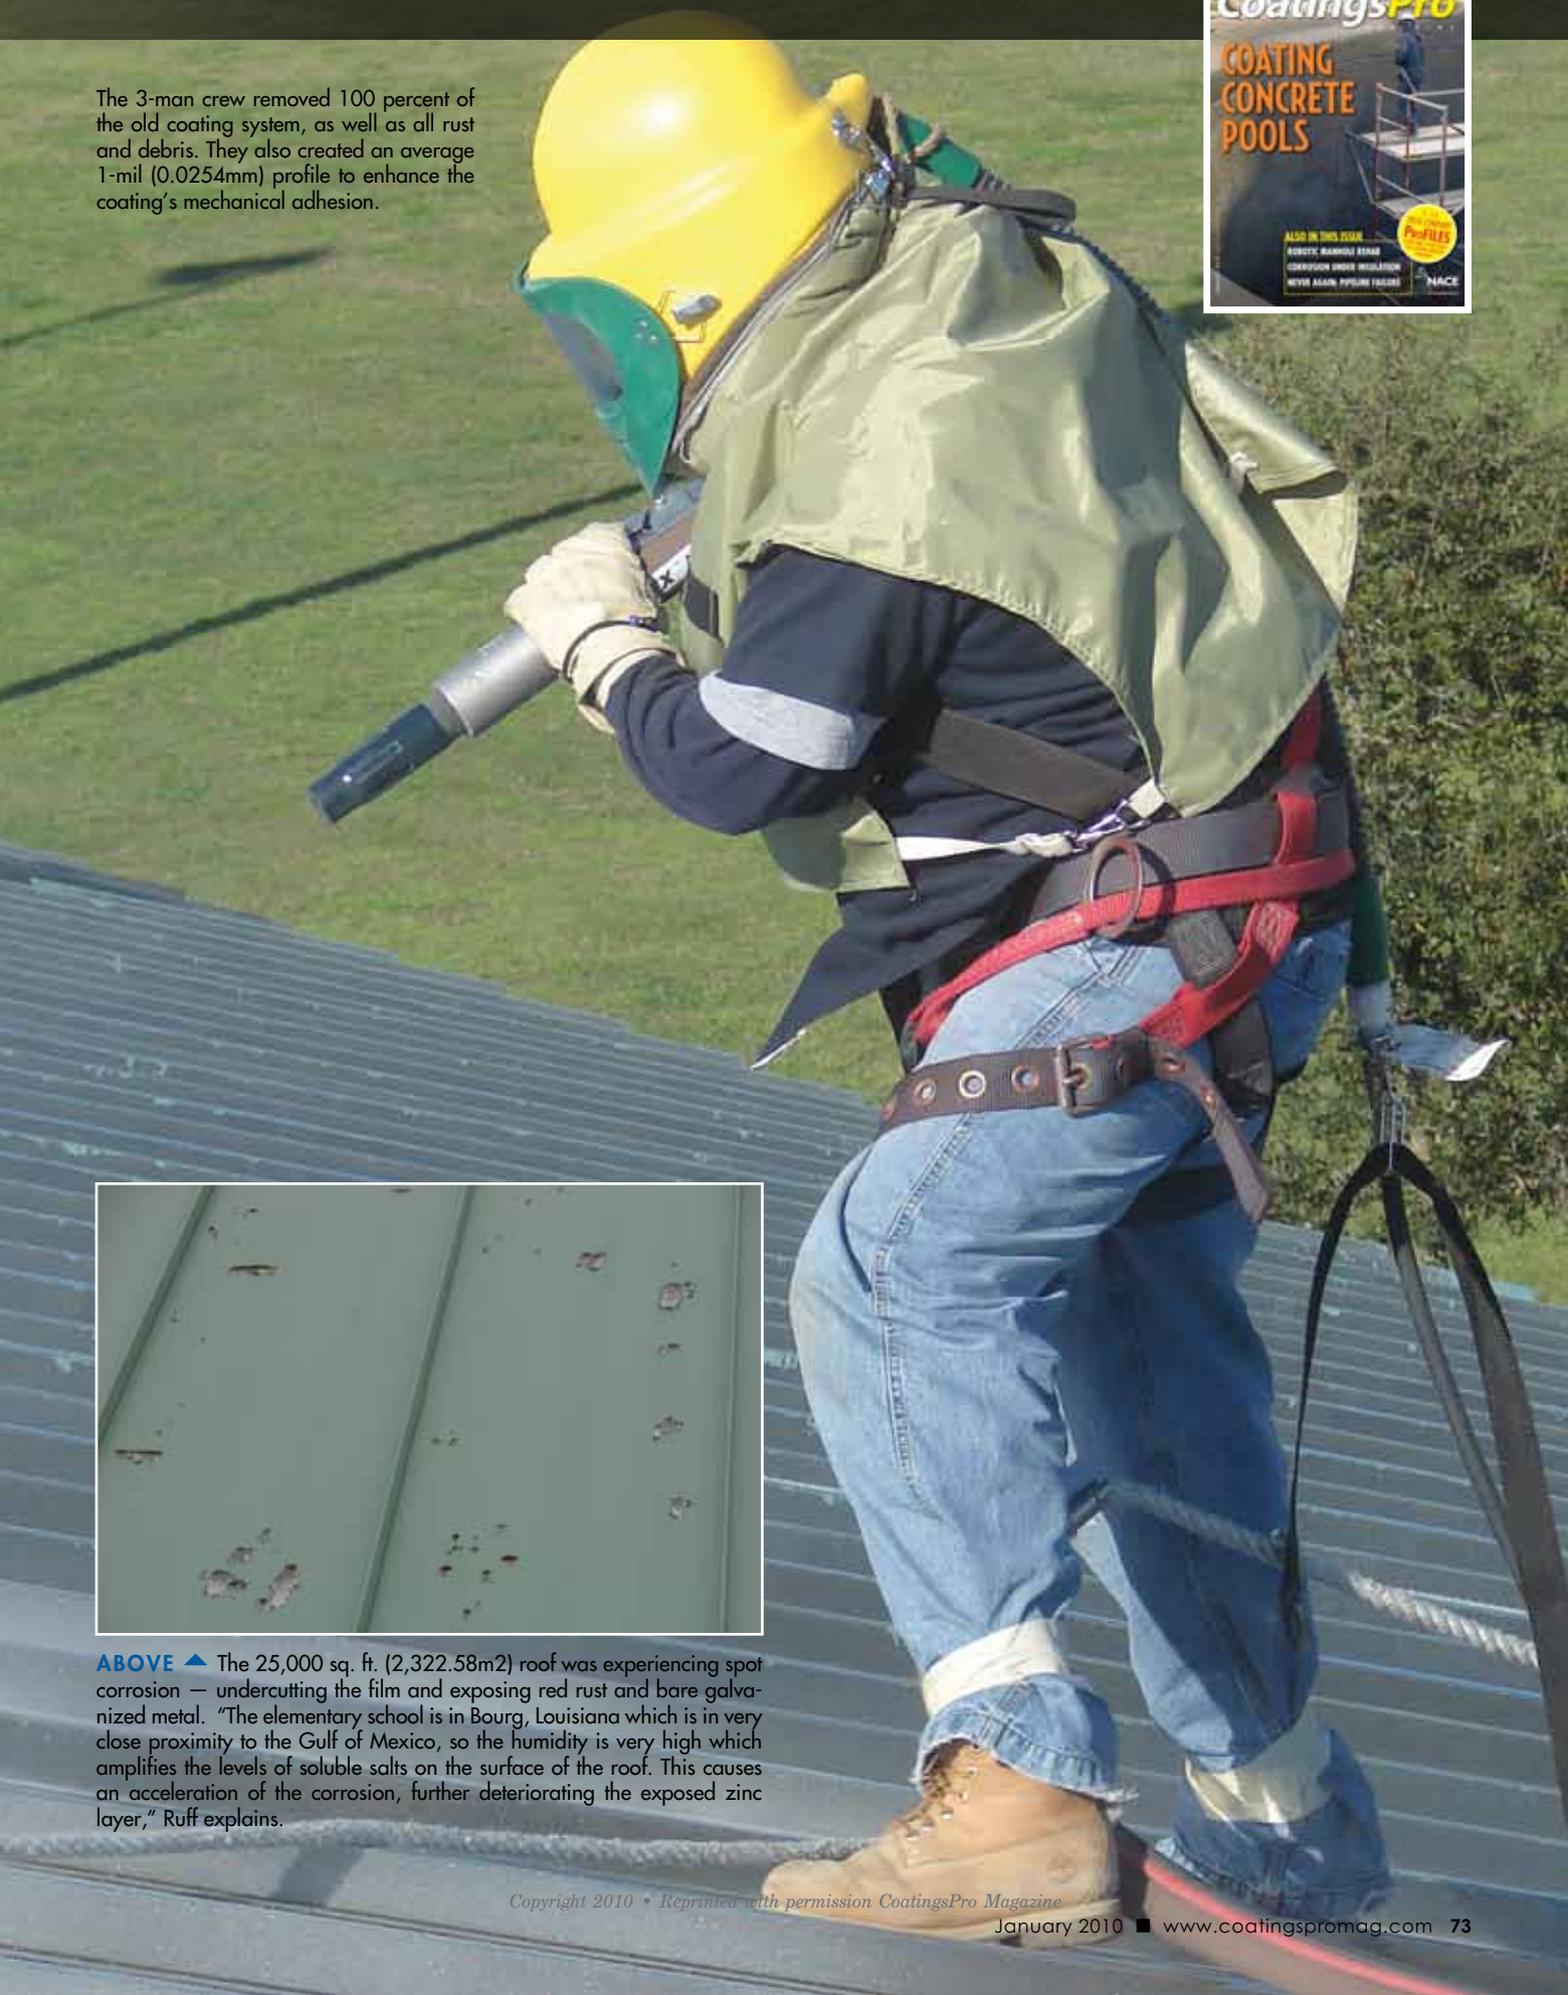
ABOVE ▲ The 25,000 sq. ft. (2,322.58m²) roof was experiencing spot corrosion — undercutting the film and exposing red rust and bare galvanized metal. “The elementary school is in Bourg, Louisiana which is in very close proximity to the Gulf of Mexico, so the humidity is very high which amplifies the levels of soluble salts on the surface of the roof. This causes an acceleration of the corrosion, further deteriorating the exposed zinc layer,” Ruff explains.

The 3-man crew removed 100 percent of the old coating system, as well as all rust and debris. They also created an average 1-mil (0.0254mm) profile to enhance the coating's mechanical adhesion.

The three-man crew (two to blast and one to clean up) removed 100 percent of the old coating system, all rust and debris, then created an average one mil (0.0254mm) profile to enhance mechanical adhesion.

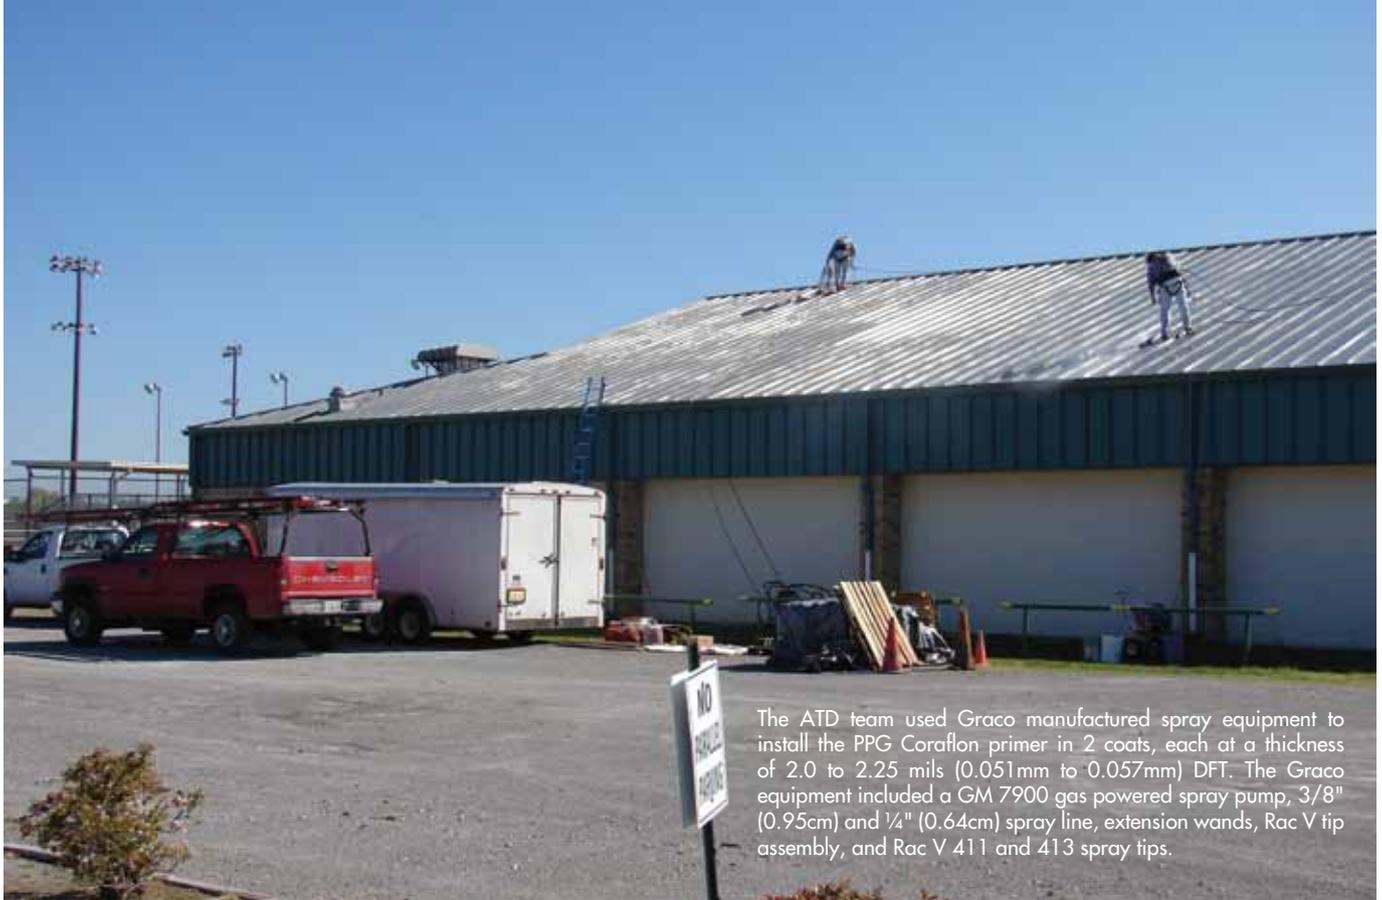
The ATD team used Graco manufactured spray equipment to install the PPG Corafon primer in 2 coats, each at a thickness of 2.0 to 2.25 mils (0.051mm to 0.057mm) DFT. The Graco equipment included a GM 7900 gas powered spray pump, 3/8" (0.95cm) and 1/4" (0.64cm) spray line, extension wands, Rac V tip assembly, and Rac V 411 and 413 spray tips.

The ATD team used Graco manufactured spray equipment to install the coating on the job. Their equipment included a GM 7900 gas powered spray pump, 3/8-inch (0.95cm) and ¼-inch (0.64cm) spray line, extension wands, Rac V tip assembly, and Rac V 411 and 413 spray tips.

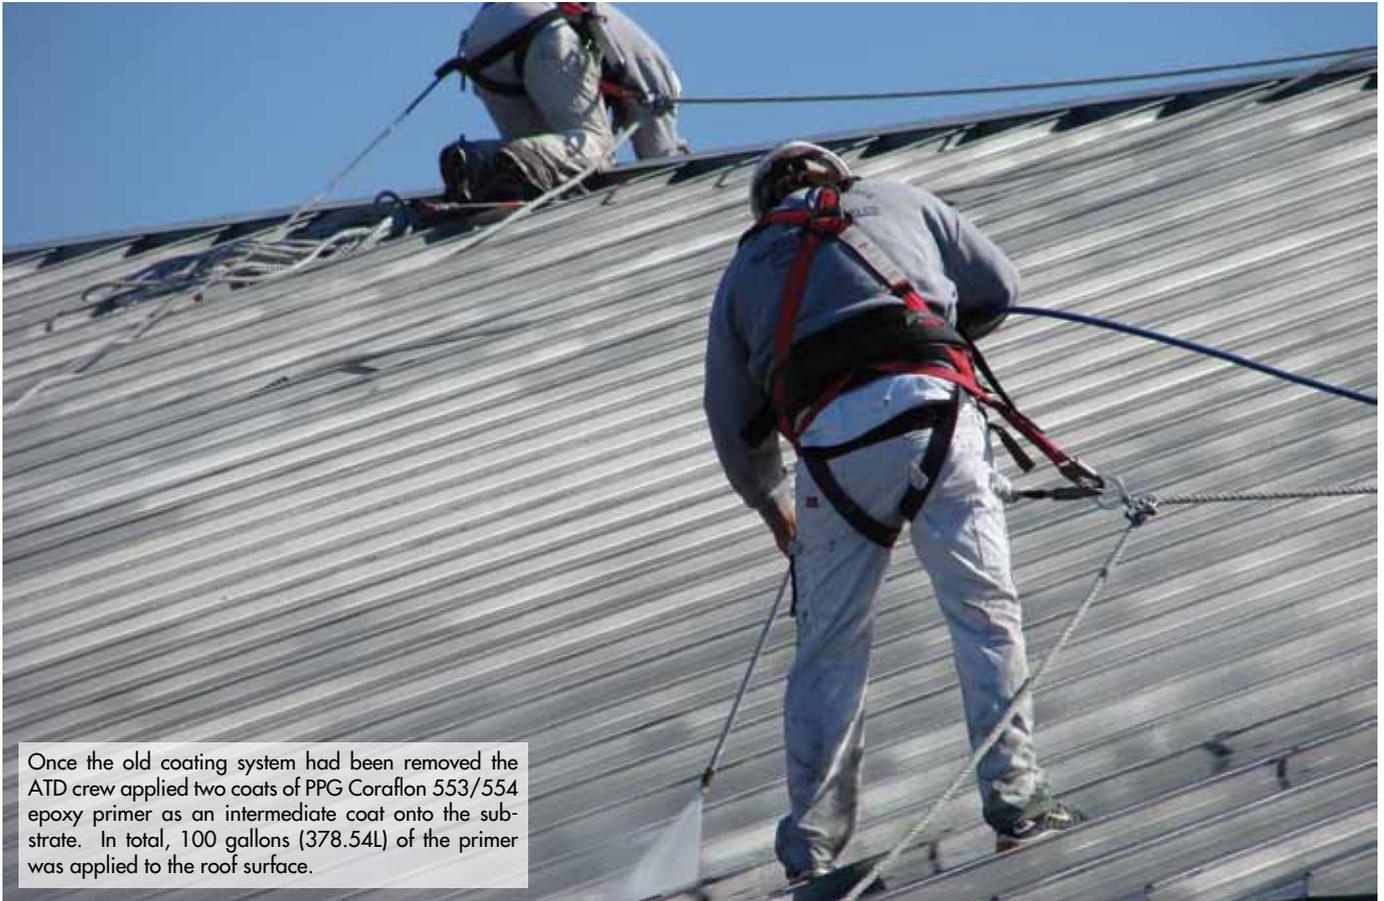
Once the old coating system had been removed the ATD crew applied two coats of PPG Coraflon 553/554 epoxy primer as an intermediate coat onto the substrate. In total, 100 gallons (378.54L) of the primer was applied to the roof surface.

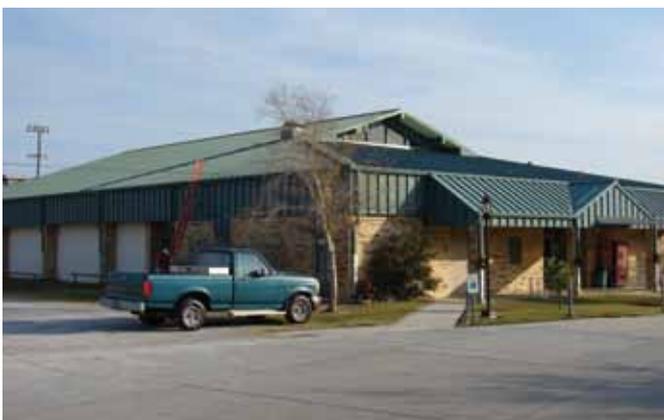
LEFT ◀ The specs required the ATD crew to completely remove the factory-applied coating system from the school’s metal roof, etch the substrate to an average 1-mil (0.03mm) profile prior to cleaning, spray-apply 2 coats of 2.0 to 2.25 mils (0.0508mm to 0.0572mm) each of PPG 553/554 Epoxy Primer, and spray-apply an additional 2 coats of Coraflon ADS for an average 1.5 mils (0.0381mm) DFT topcoat.

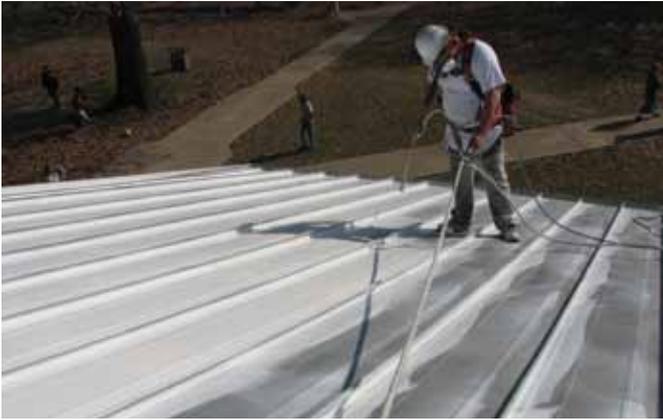
ABOVE ▲ The Coraflon product has a 16.2 to 1 ratio, making it more complicated to apply than coatings that have a 1:1, 2:1, or even 3:1 ratio. “There is a definite learning curve when applying the product,” relates Ruff.

The Coraflon product has a 16.2 to 1 ratio, making it more complicated to apply than coatings that have a 1 to 1, 2 to 1, or even 3 to 1 ratio. “There is a definite learning curve when applying the product,” relates Ruff.

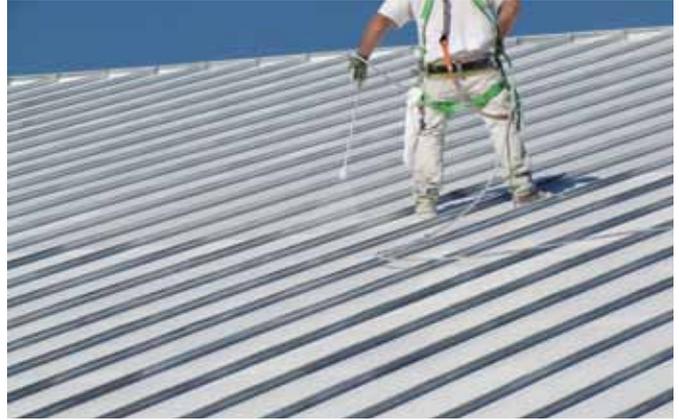
ABOVE ▲ In addition to the safety of the students and neighbors below, the personal safety of the crew was important. Ruff and his team wore Spider construction harnesses with D-ring positioning using rope grabs and 5/8" (1.59cm) rope, to remain safe and comfortable when working on the steeply pitched roof. They also wore respirators and fresh air blast helmets with peel-away shields.

During each step of the project, from surface prep to the final application of the topcoat, the personal safety of the crewmembers was a top priority. Spider construction harnesses with D-ring positioning were used, along with rope grabs and 5/8-inch (1.59cm) rope, to keep personnel safe and comfortable during work periods. The crew wore respirators and fresh air blast helmets with peel-away shields.

“It was extremely important that the crew be safe and comfortable because, with the 7:12 pitch of the roof, hand rails couldn’t be installed. The crew had to rappel, which is very physically demanding,” says Ruff.
