Reading, Writing, And Rooftop Coating: Recoating A Louisiana Elementary School

BY JENNIFER FRAKES
PHOTOS COURTESY OF ATD

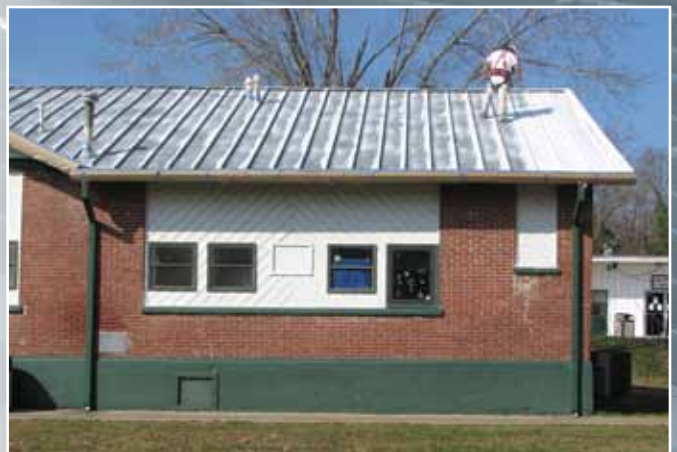
ABOVE ▲ In all, the ATD crew applied 60 gallons (227.13L) of PPG Coraflon ADS, a 2-component fluoropolymer coating, on top of the Coraflon primer. Using the same Graco equipment, the Coraflon ADS topcoat was spray-applied in two coats to achieve a total thickness of 5.5 to 6.0 mils (0.14mm to 0.15mm) DFT.

For this project, the two-man ATD crew applied 60 gallons (227.13L) of PPG Corafon ADS, a two-component fluoropolymer coating, to the substrate. Prior to installing the topcoat, the crew applied two coats of PPG Corafon 553/554 epoxy primer, which is recommended by PPG for use as the intermediate coat on steel and aluminum substrates. In total, 100 gallons (378.54L) of the primer was applied to the roof surface. Each coat of primer was applied at a thickness of 2.0 to 2.25 mils (0.051mm to 0.057mm) DFT, and the topcoat was applied in two

coats to achieve a total dry film thickness of 5.5 to 6.0 mils (0.14mm to 0.15mm) DFT.

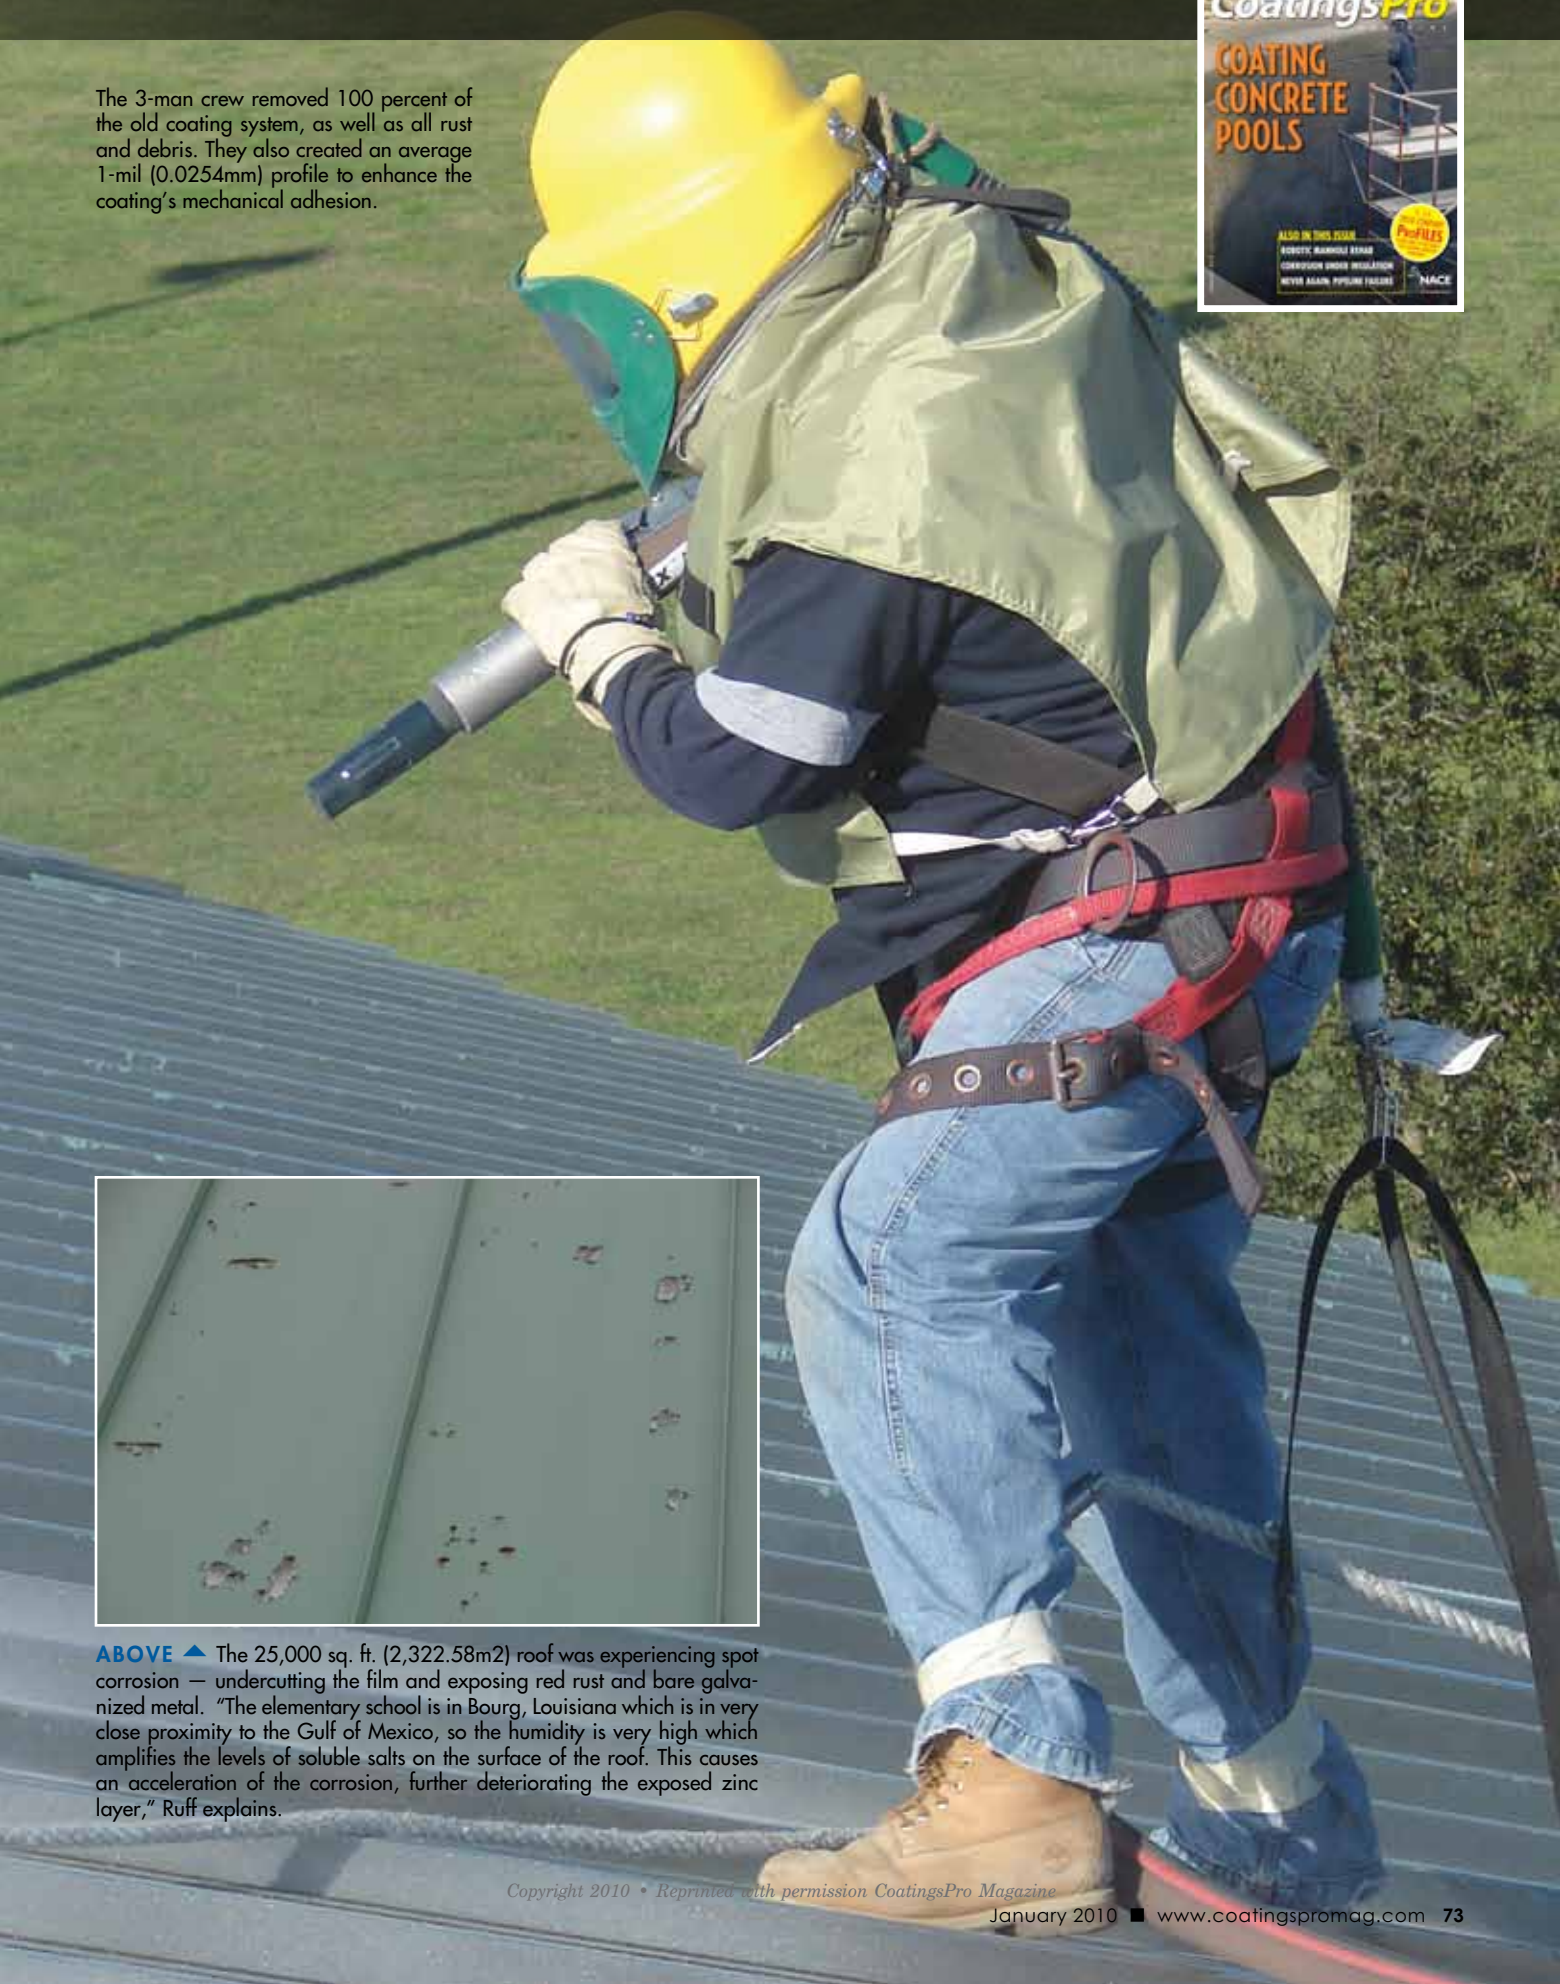
The 3-man crew removed 100 percent of the old coating system, as well as all rust and debris. They also created an average 1-mil (0.0254mm) profile to enhance the coating's mechanical adhesion.

The three-man crew (two to blast and one to clean up) removed 100 percent of the old coating system, all rust and debris, then created an average one mil (0.0254mm) profile to enhance mechanical adhesion.

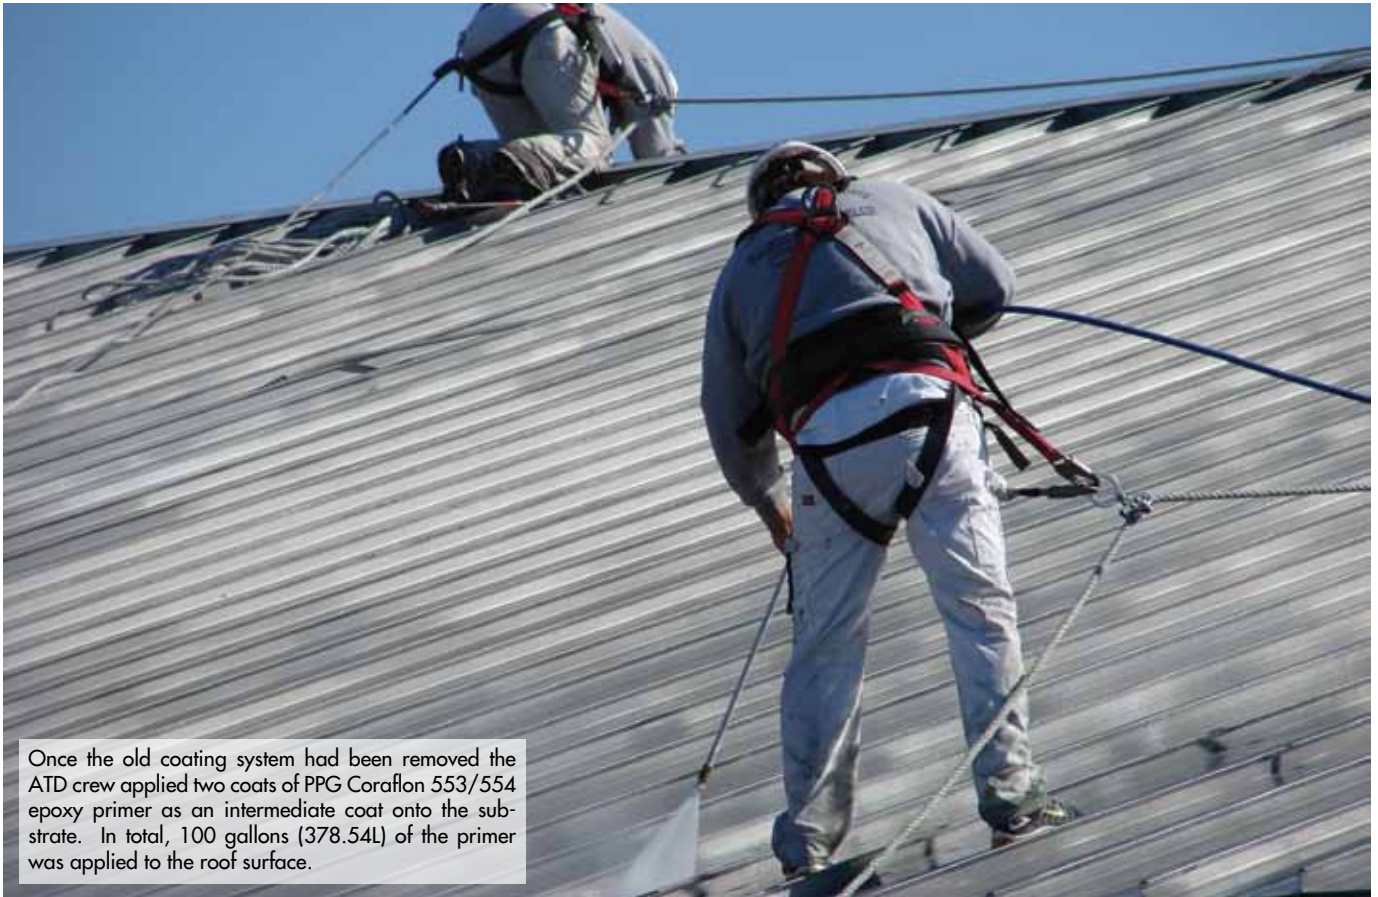
Once the old coating system had been removed the ATD crew applied two coats of PPG Corafon 553/554 epoxy primer as an intermediate coat onto the substrate. In total, 100 gallons (378.54L) of the primer was applied to the roof surface.

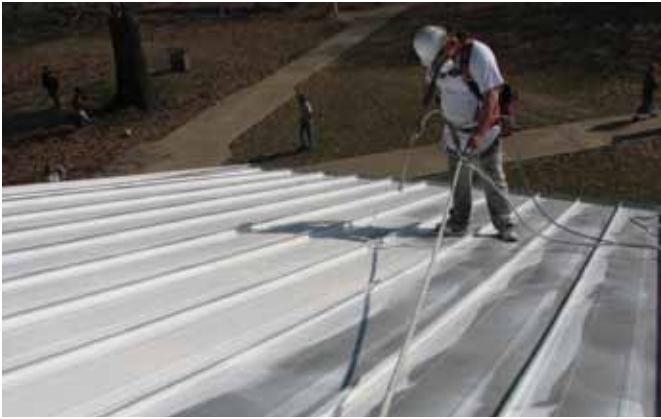
ABOVE ▲ The Coraflon product has a 16.2 to 1 ratio, making it more complicated to apply than coatings that have a 1:1, 2:1, or even 3:1 ratio. “There is a definite learning curve when applying the product,” relates Ruff.

The Coraflon product has a 16.2 to 1 ratio, making it more complicated to apply than coatings that have a 1 to 1, 2 to 1, or even 3 to 1 ratio. “There is a definite learning curve when applying the product,” relates Ruff.

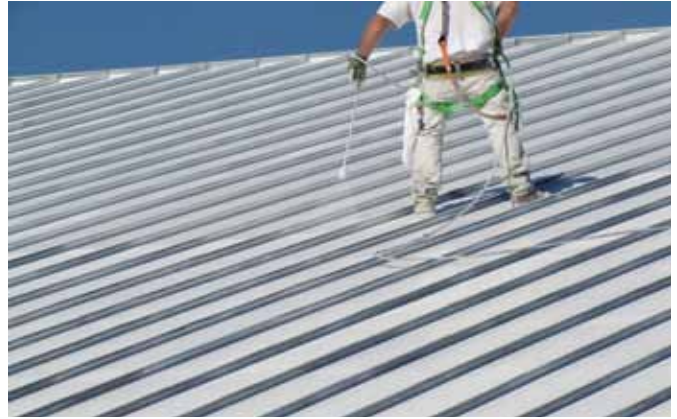
ABOVE ▲ In addition to the safety of the students and neighbors below, the personal safety of the crew was important. Ruff and his team wore Spider construction harnesses with D-ring positioning using rope grabs and 5/8" (1.59cm) rope, to remain safe and comfortable when working on the steeply pitched roof. They also wore respirators and fresh air blast helmets with peel-away shields.

During each step of the project, from surface prep to the final application of the topcoat, the personal safety of the crewmembers was a top priority. Spider construction harnesses with D-ring positioning were used, along with rope grabs and 5/8-inch (1.59cm) rope, to keep personnel safe and comfortable during work periods. The crew wore respirators and fresh air blast helmets with peel-away shields.

“It was extremely important that the crew be safe and comfortable because, with the 7:12 pitch of the roof, hand rails couldn’t be installed. The crew had to rappel, which is very physically demanding,” says Ruff.
